YUNEX Technical Bulletin STAB22-0132

Temporary Concession Change on Helios Fixing Kits

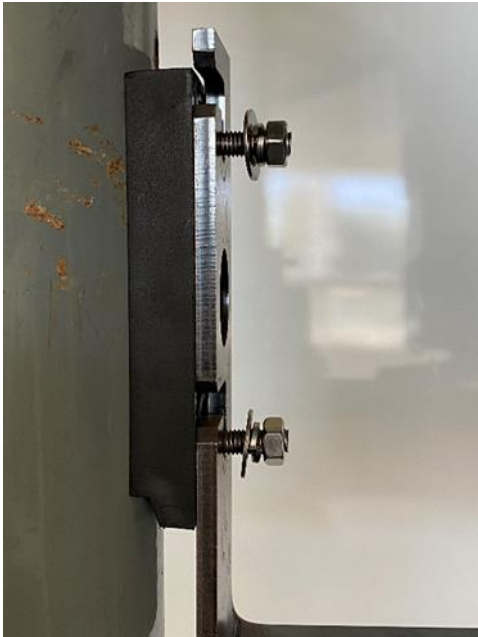
Figure 1: Slotted bracket with temp fixing kit

The new fixing arrangement is shown in figures 1 & 2. Note that the nuts and washers **must** still be partially assembled before lifting the signal head into position.

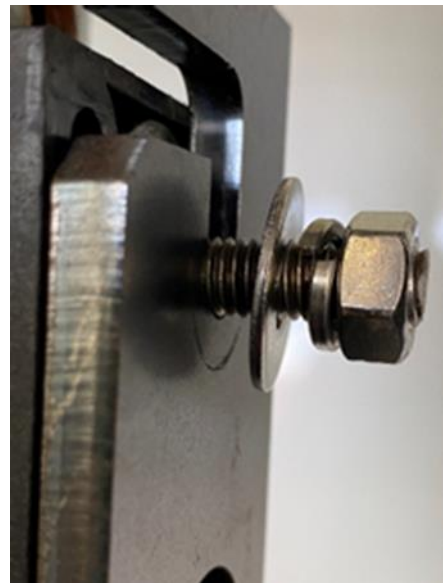
Figure 2: Temp washer in correct position

HOWEVER it is imperative that the washers do not slide underneath the bracket during lifting of the signal head, they must be on the nut side of the bracket before final installation. If the washers have been pushed behind the bracket during lifting and positioning of the signal head, then they must be repositioned before tightening the nut.
