# YUNEX Technical Bulletin STAB22-0133

Plus+ Wait PDU PCB Change

YUNEX  
TRAFFIC

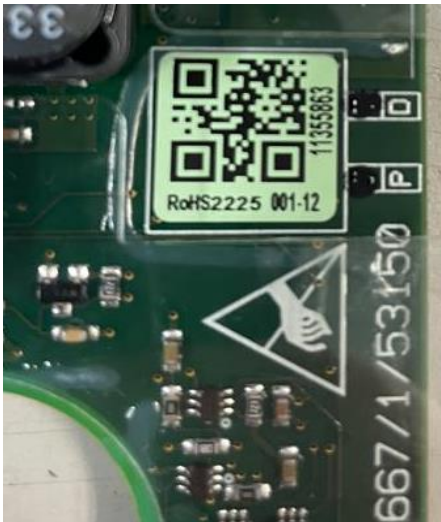
The issue number can be identified on the QR code sticker where the end of the part number (001), is followed by the issue number.

In this photo we have 001-12, so its issue 12 of the board.

Therefore it is recommended to check the items you have in stock and **all 667/1/53150/001 boards at issue 12, 13, 14 and 15** should be returned to Poole for repair/upgrade. New boards using the corrected capacitor will be issue 16 and above. All boards before issue 12 will use the previous transceiver and capacitor and are therefore ok to use (no need to change these).
